Asbestos removal

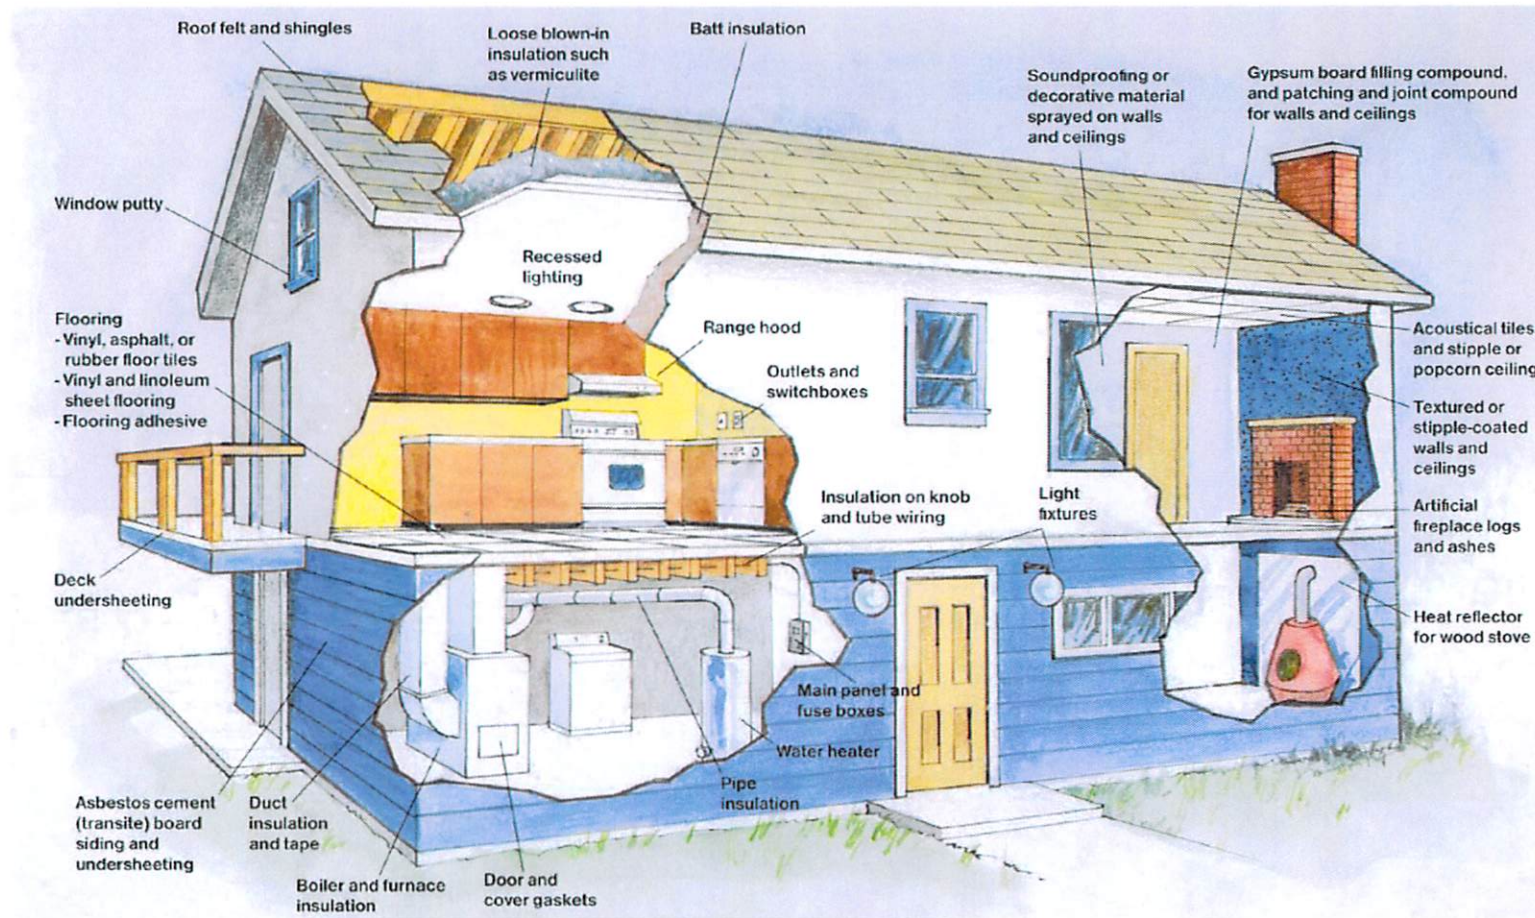
Possible sources of asbestos

These products may contain asbestos, depending on the age of the building and the materials used to manufacture the product.

Until 1978, there were over 3000 products containing asbestos used in house construction. When renovating or demolishing older homes, there is a high probability of encountering asbestos-containing materials. Asbestos-containing materials that were once commonly used in residential construction are shown in the following illustration.
